Evidence supporting the existence of the paleolandslide: Identification of the failure plane and the east margin of the landslide

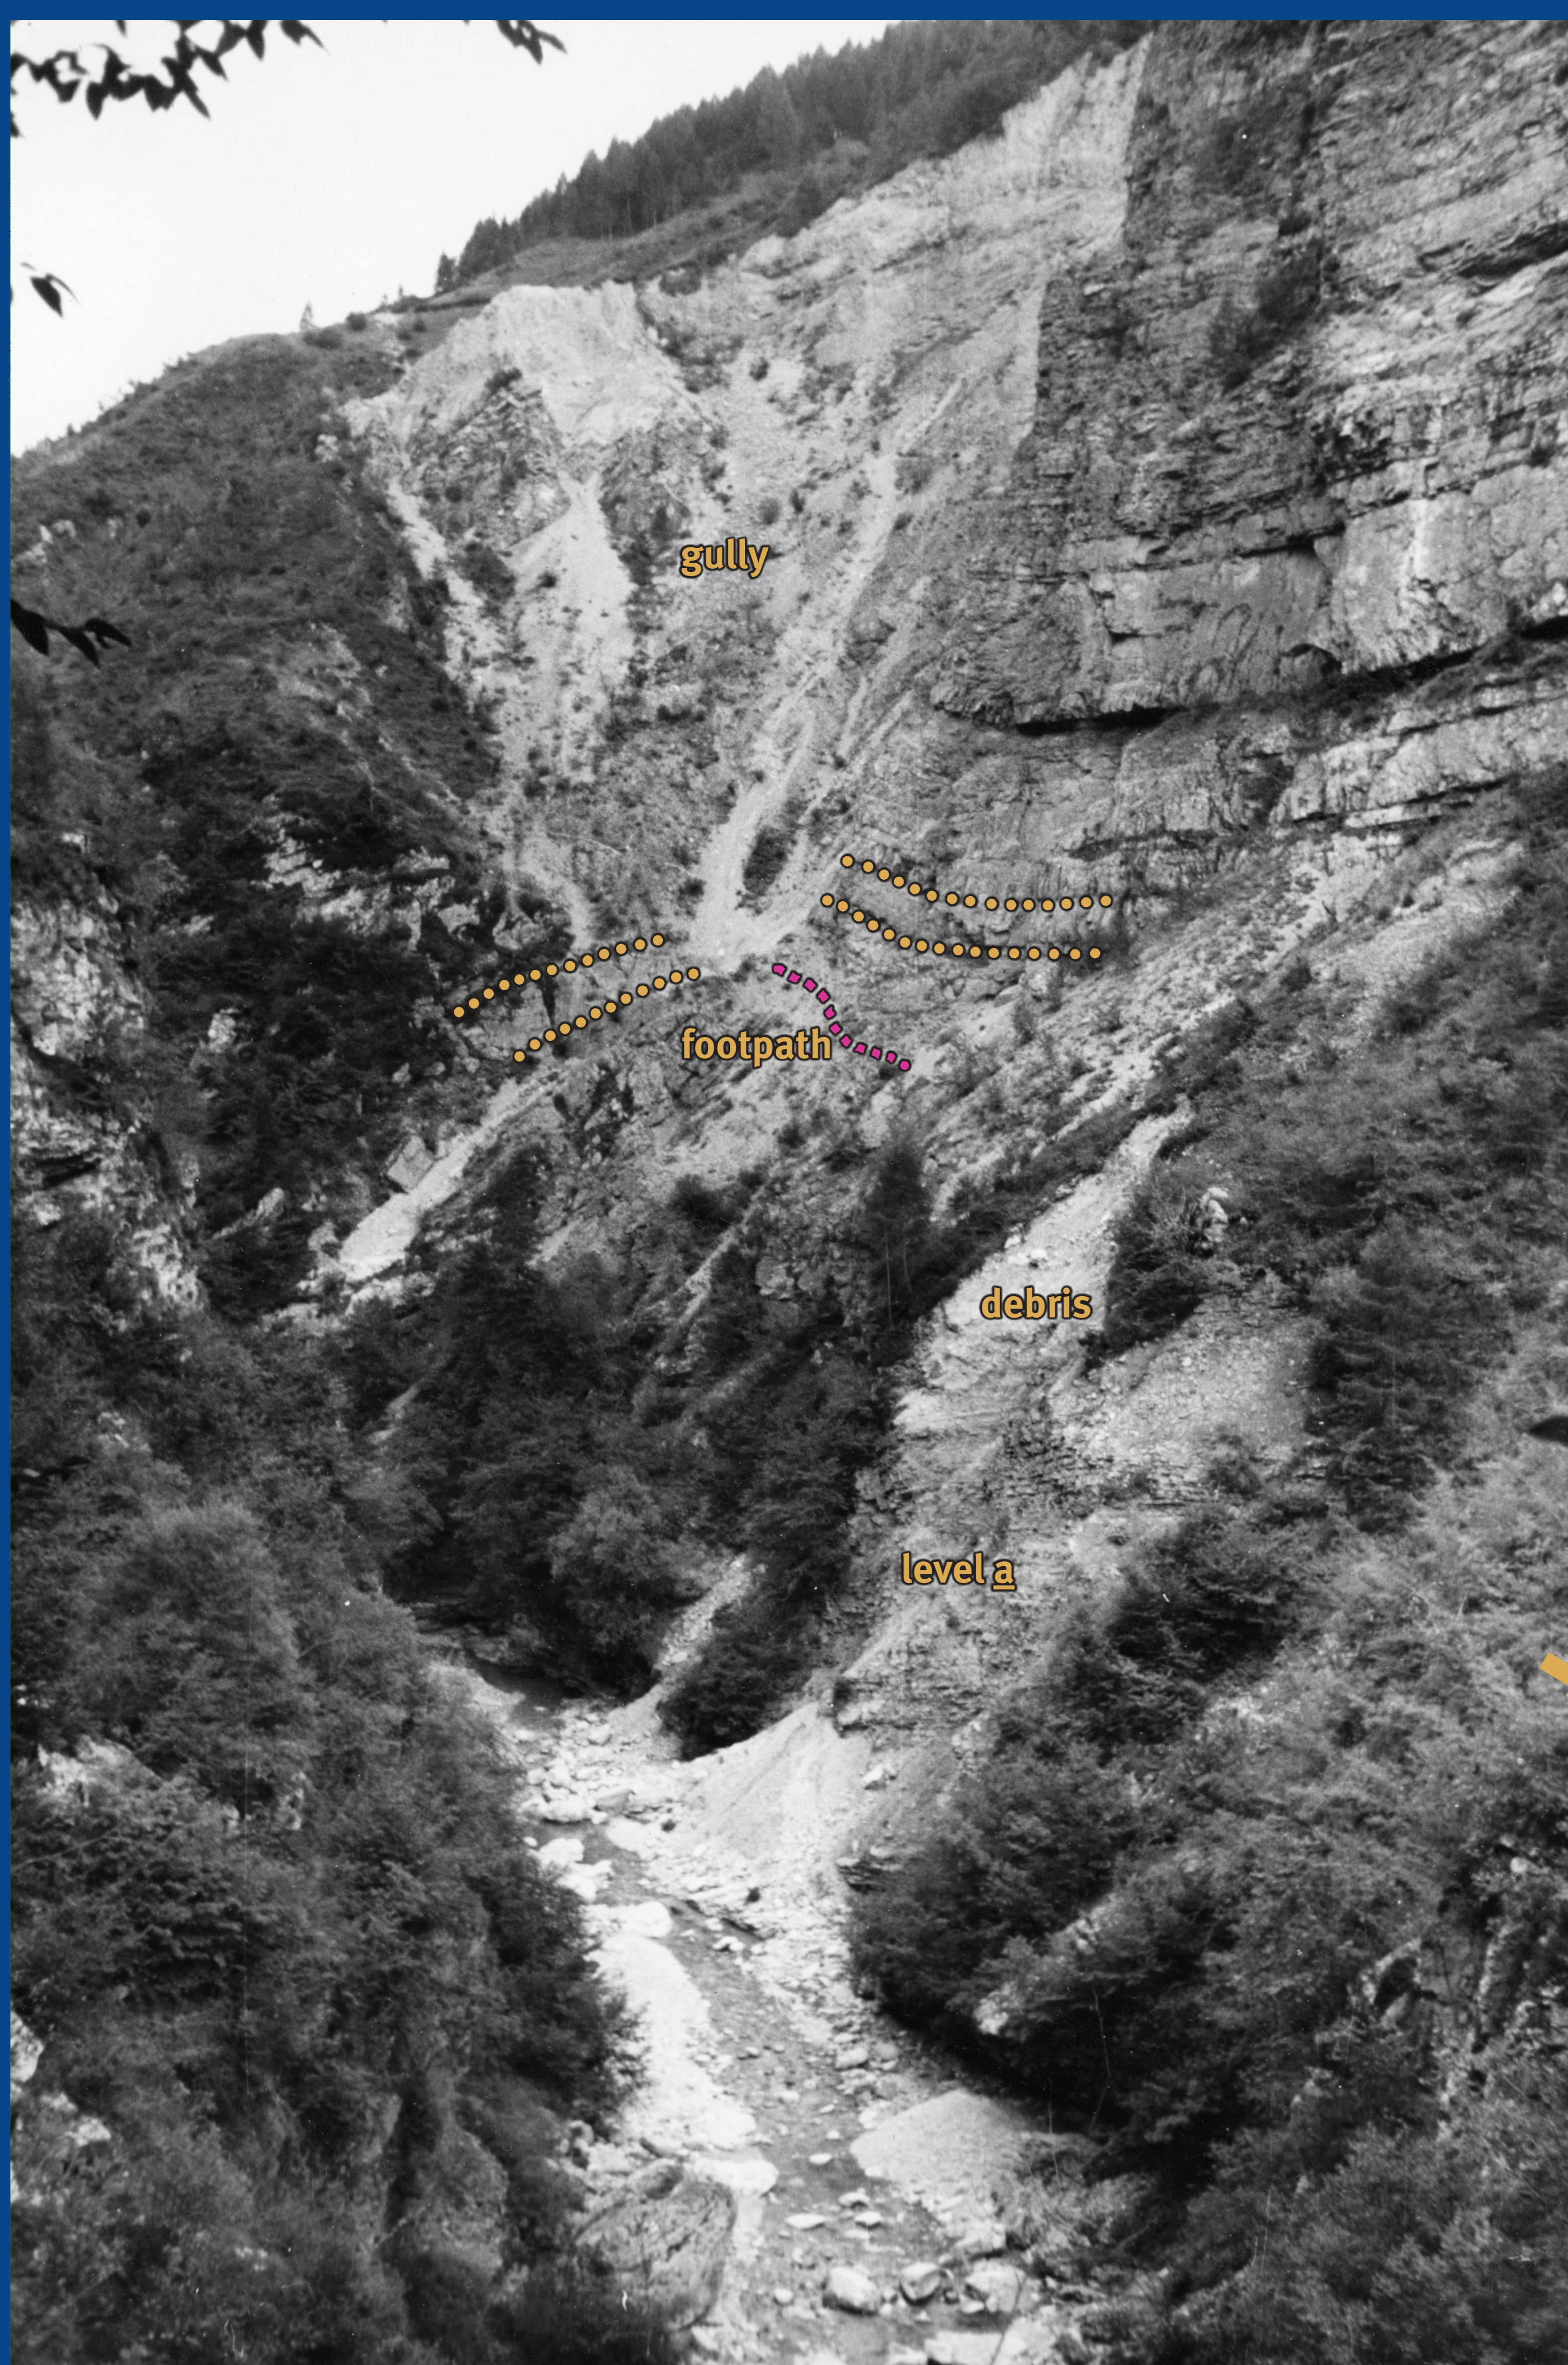
10 - The bottom of the Vaiont Valley and the northeast edge of the paleolandslide

The north wall (photographs 8 and 9 of panel 4 and photograph 17 of panel 8) bordered the so-called eastern wall, which Edoardo Semenza described in this manner: "Along the eastern wall of the paleoslide the situation was dramatic: [...] deep cavities [...] heavily fractured rock [...] vertical cracks." A funnel-shaped gully filled with debris is visible at the centre of the photograph.

Also evident is the strong discordance between the upward-folded layers of the ancient landslide at the right and rock layers to the left of and below the gully that dip steeply towards the northeast. The cataclasite visible in photograph 11 was found during an excavation along the small footpath just below the upper wall. Note also the talus and, beneath it, the bedrock layers.

The photographs in this panel provide the clearest evidence of the existence of the paleolandslide. They are the only ones that show position, thickness and eastern margin of the sliding plane mass.

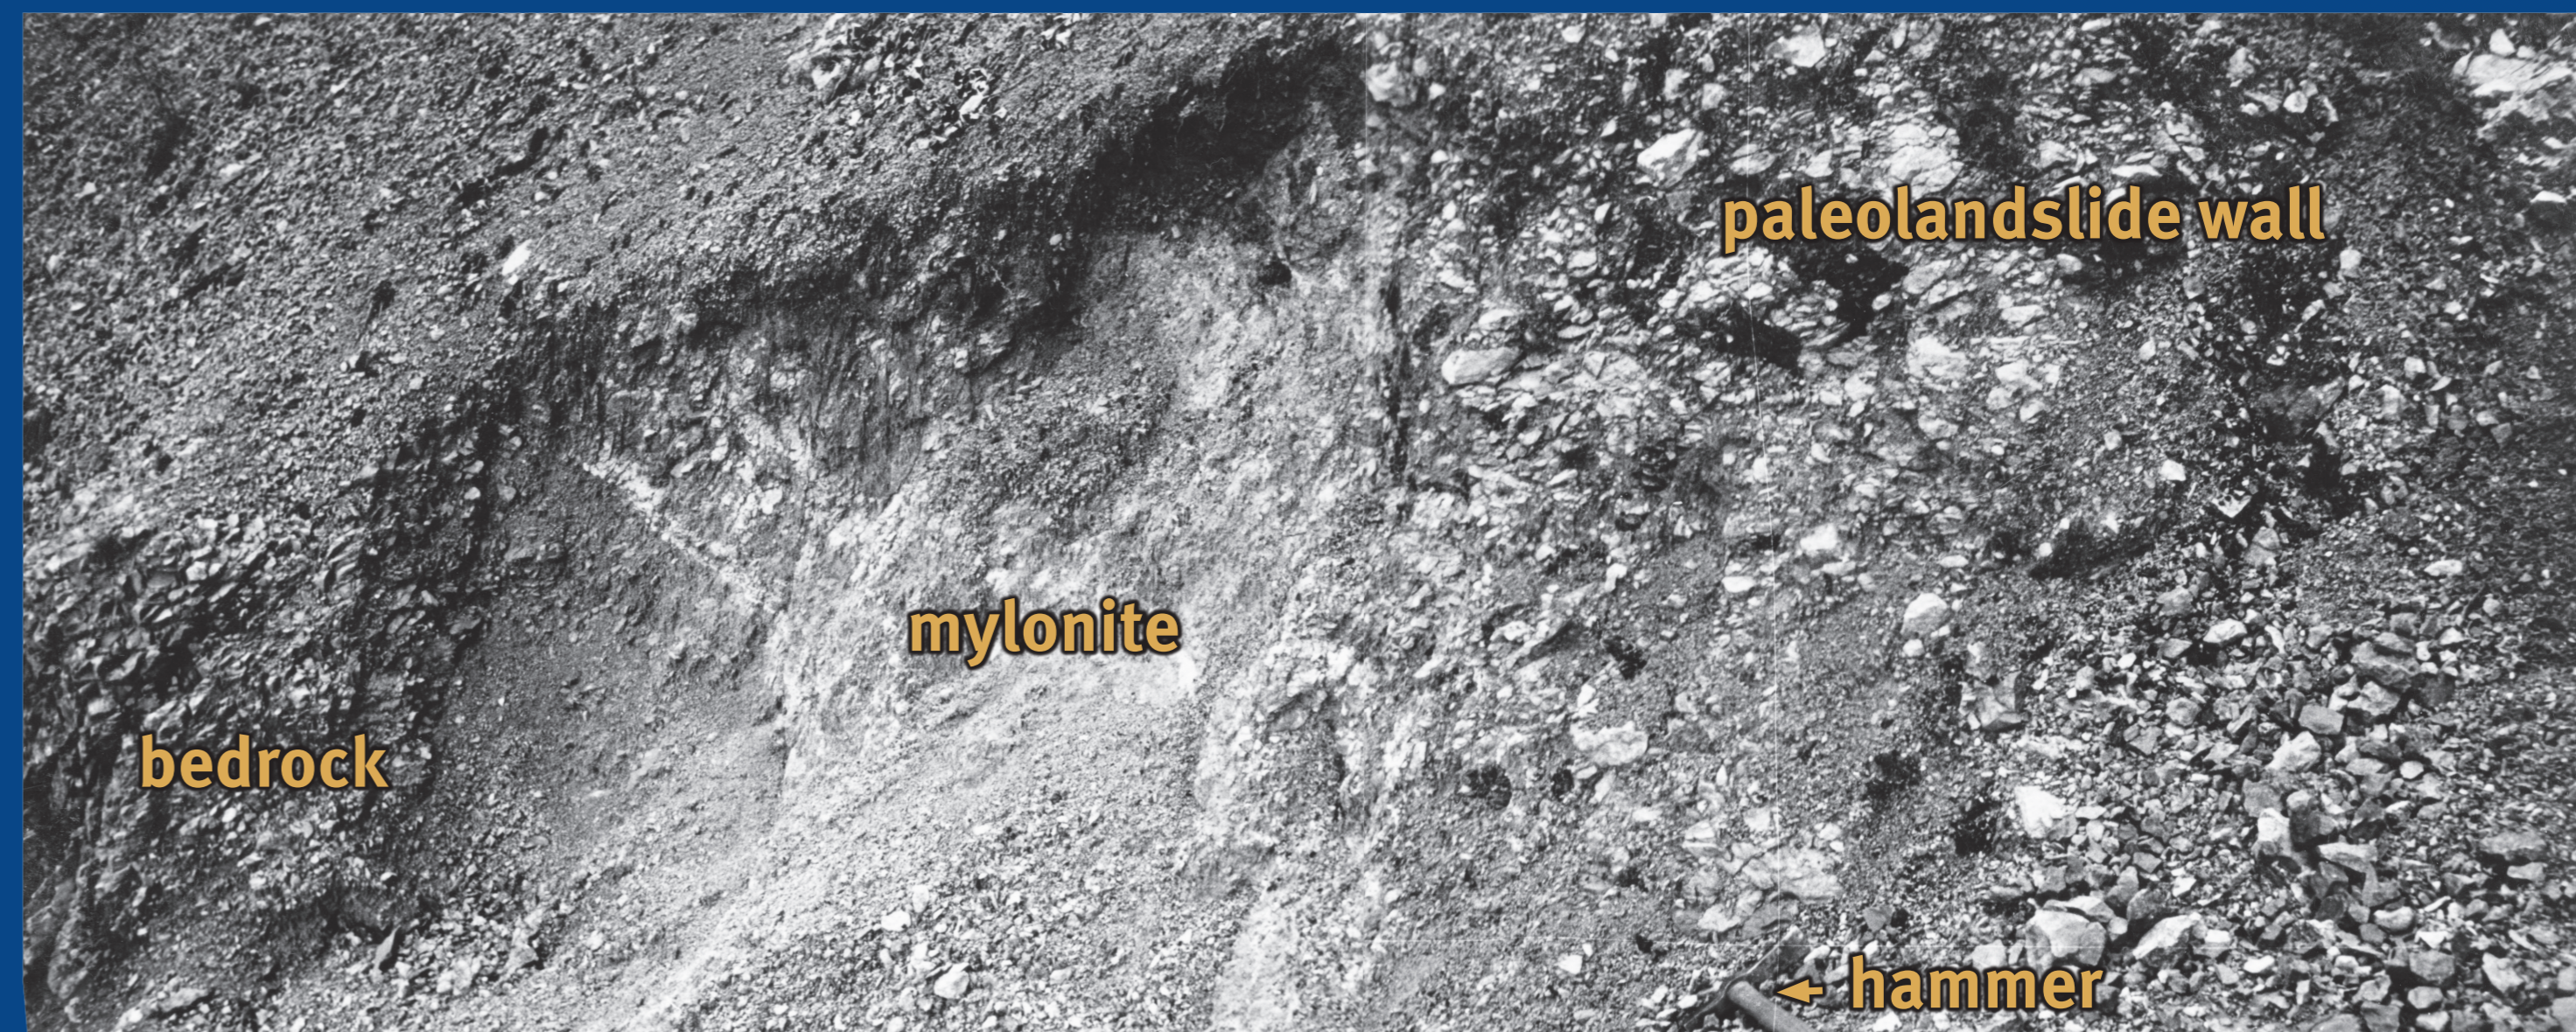
11 - The excavation that exposed the failure surface

The excavation next to the small path visible in photograph 10 exposed cataclasites that separated the paleolandslide (to the upper right) from fractured bedrock (lower left).

The hammer at the lower right provides a sense of scale – the cataclasites at this place are about 1 meter thick.

Cataclasites and tectonic breccias overlying intact bedrock were exposed in a small excavation through the talus accumulation shown in photograph 8 of panel 4 (photographs 10 and 11). The cataclasites occurred in Fonzaio Limestone containing thin clayey interlayers, the same horizon associated with the catastrophic 1963 failure. Edoardo Semenza extended the cataclasites within the Fonzaio Formation along the entire north wall and ascribed them to the failure of the paleolandslide. He furthermore recognized that the geological discontinuity between the east wall, where the subhorizontally layered landslide mass rested on cataclasites, and the intact rock masses farther east marked a fault (the Col Tramontin Fault). This boundary proved to be significant, as it marked the lateral right boundary of the 1963 landslide.

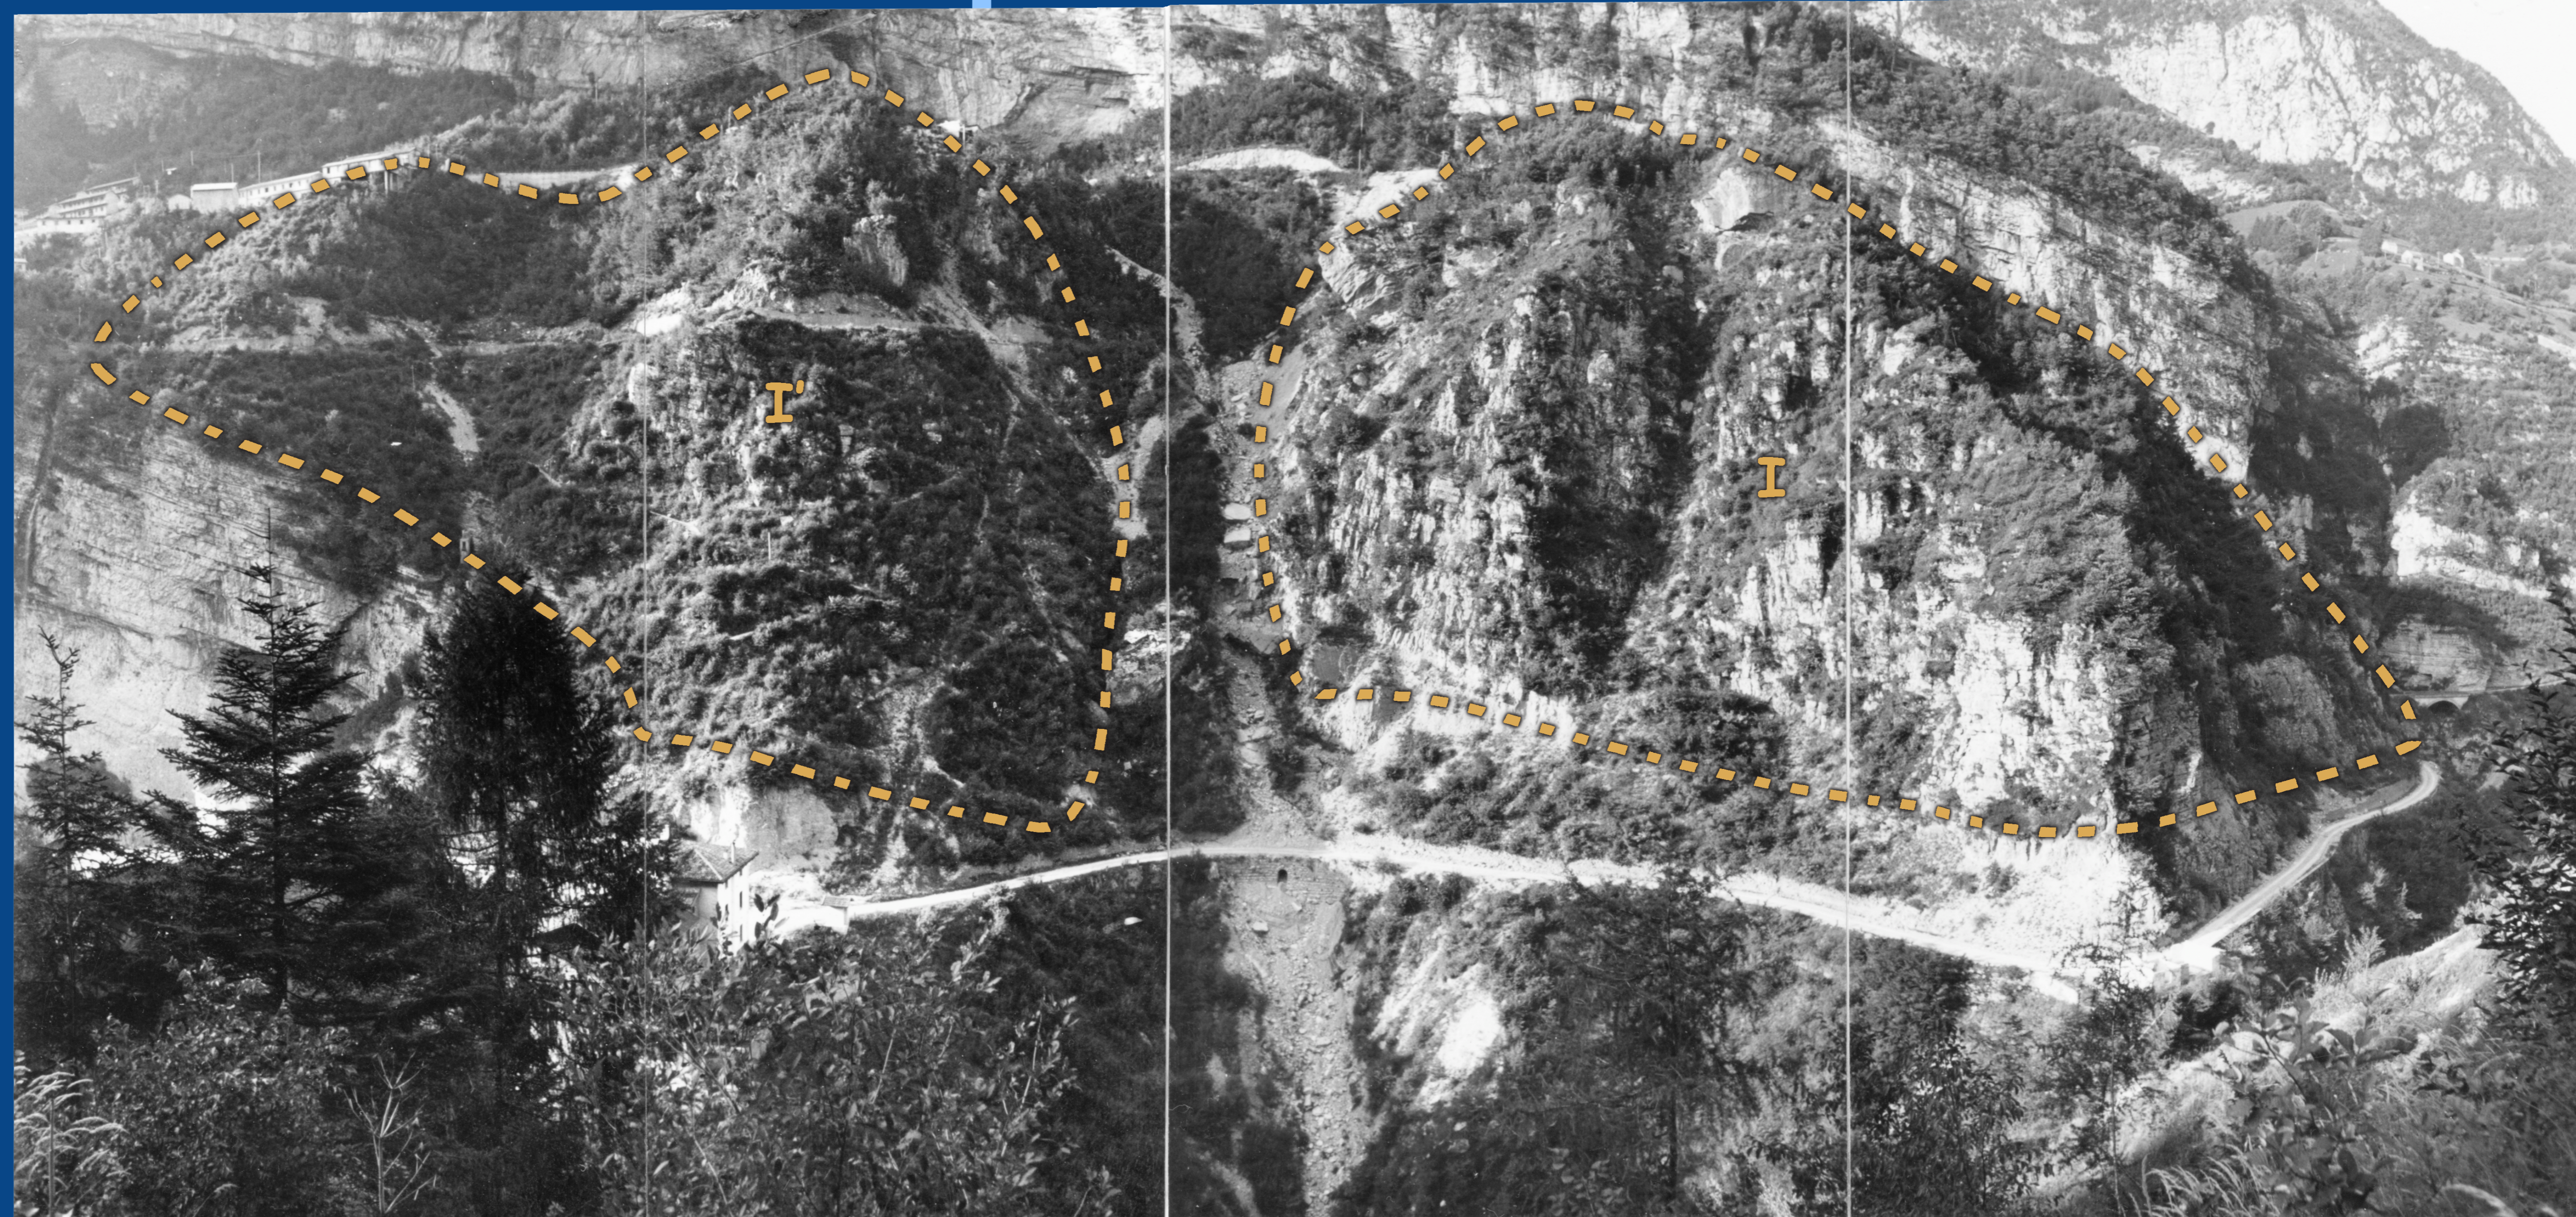
12 - North side of the Vaiont Valley just upstream of the Colombar Bridge

At the top, the building yard (left), the new road and a bedrock wall; at the bottom the old road; in the middle left an abandoned road. Note the contrast between the rocky wall that overhangs the new road (currently a practice wall for climbers) and slopes downward to the right and left, and the rock masses (I and I') that rise between the two roads in the central part of the photo. Bedrock in the rocky wall dips regularly towards the right (east), whereas the central rock masses are heavily fractured, with variable dip. The rock mass at the right (I) lies on loose sediment; after 1963 it was named "Colle Isolato" (see text and more photographs of Colle Isolato in the following two panels).
