## The discovery of the upper margin of the paleolandslide

### The development of the M-shaped crack below Monte Toc

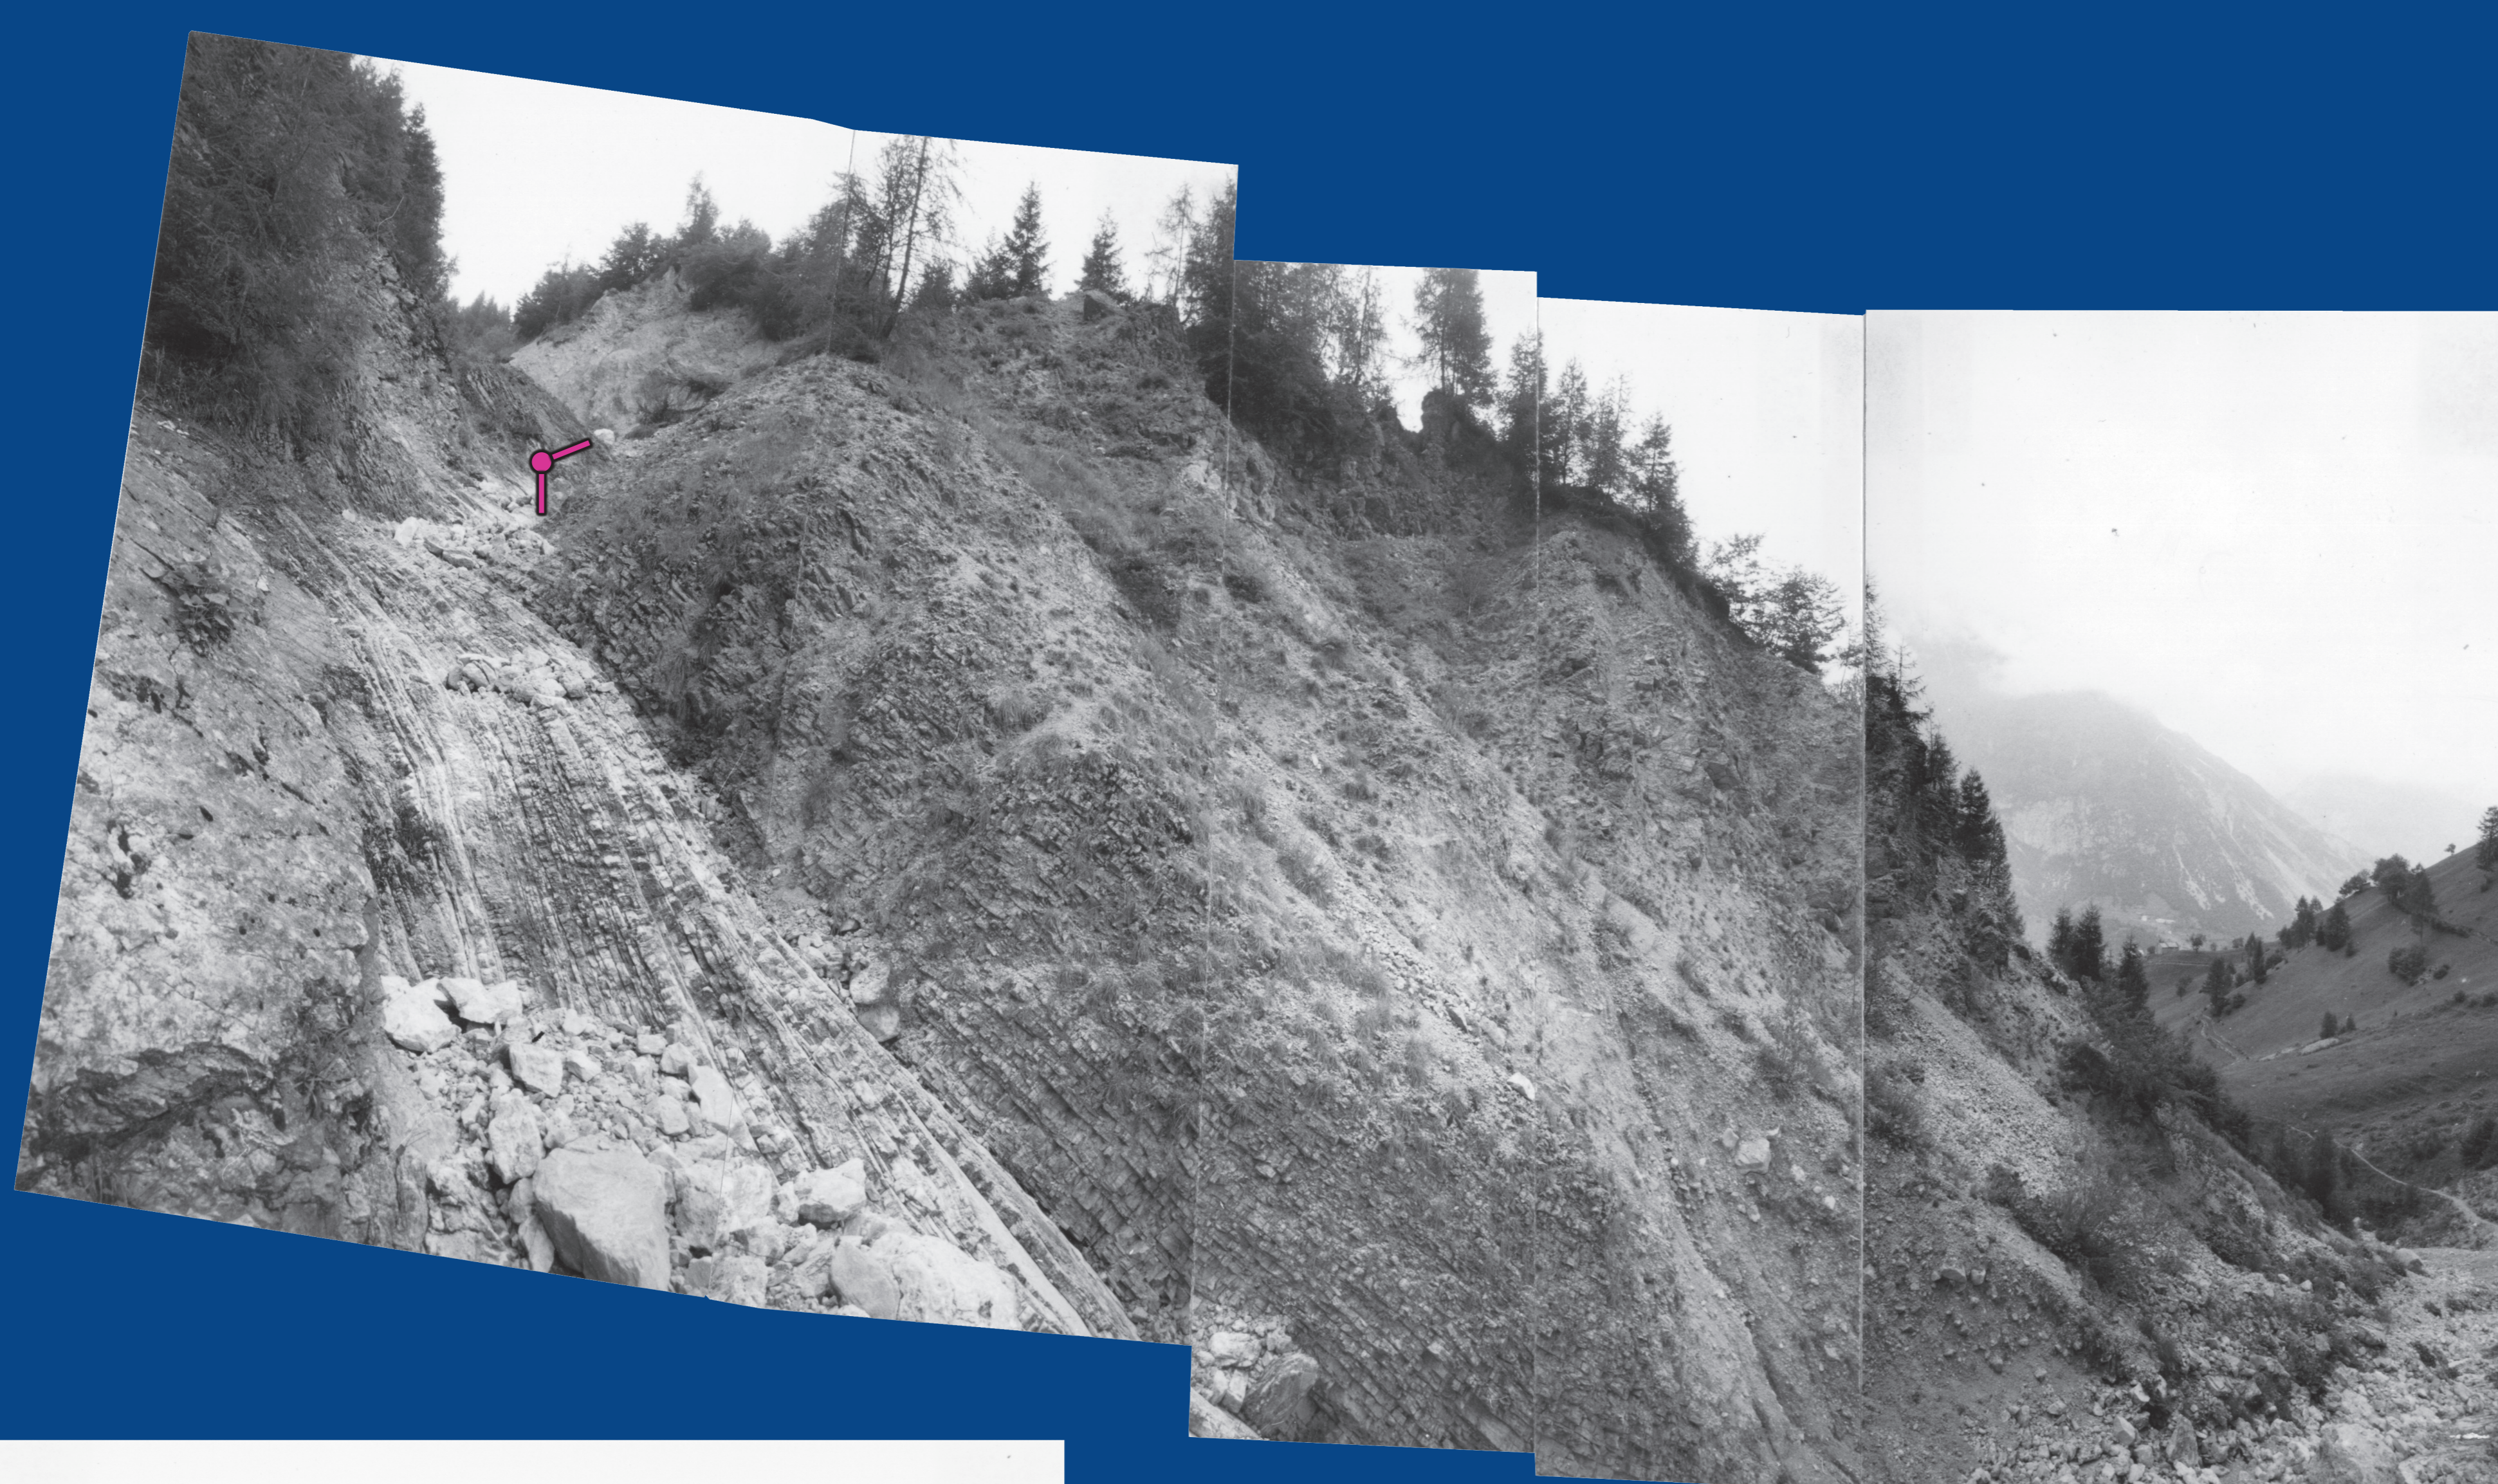
#### 21 - Discovery of the upper margin of the paleolandslide

The western branch of the Massalezza Stream; the lower part on the right; the upper part on the left. Also visible is a portion of the head of the paleolandslide just below 1000 m asl. Layers in bedrock at the left side of the photograph dip 40° to the north. Some meters of mylonite and cataclasite are exposed in the gully. A perimeter crack developed in this area months later. To the right of this zone are blocks belonging to the folded and heavily fractured Fonzaso Formation. The remarkable thickness of the mylonite and cataclasite highlights the importance of the movement plane of the paleolandslide. This surface controlled the movements of the Monte Toc slope from the spring of 1960 until October 9, 1963. The approximate location of photograph 22, taken downslope, is indicated.

Note the small ledge produced by sliding of the overlying rock mass towards the left. This ledge was not present in August 1960. The hammer on the left side of the ledge provides scale. The approximate point of view of the photo is indicated in photograph 21.

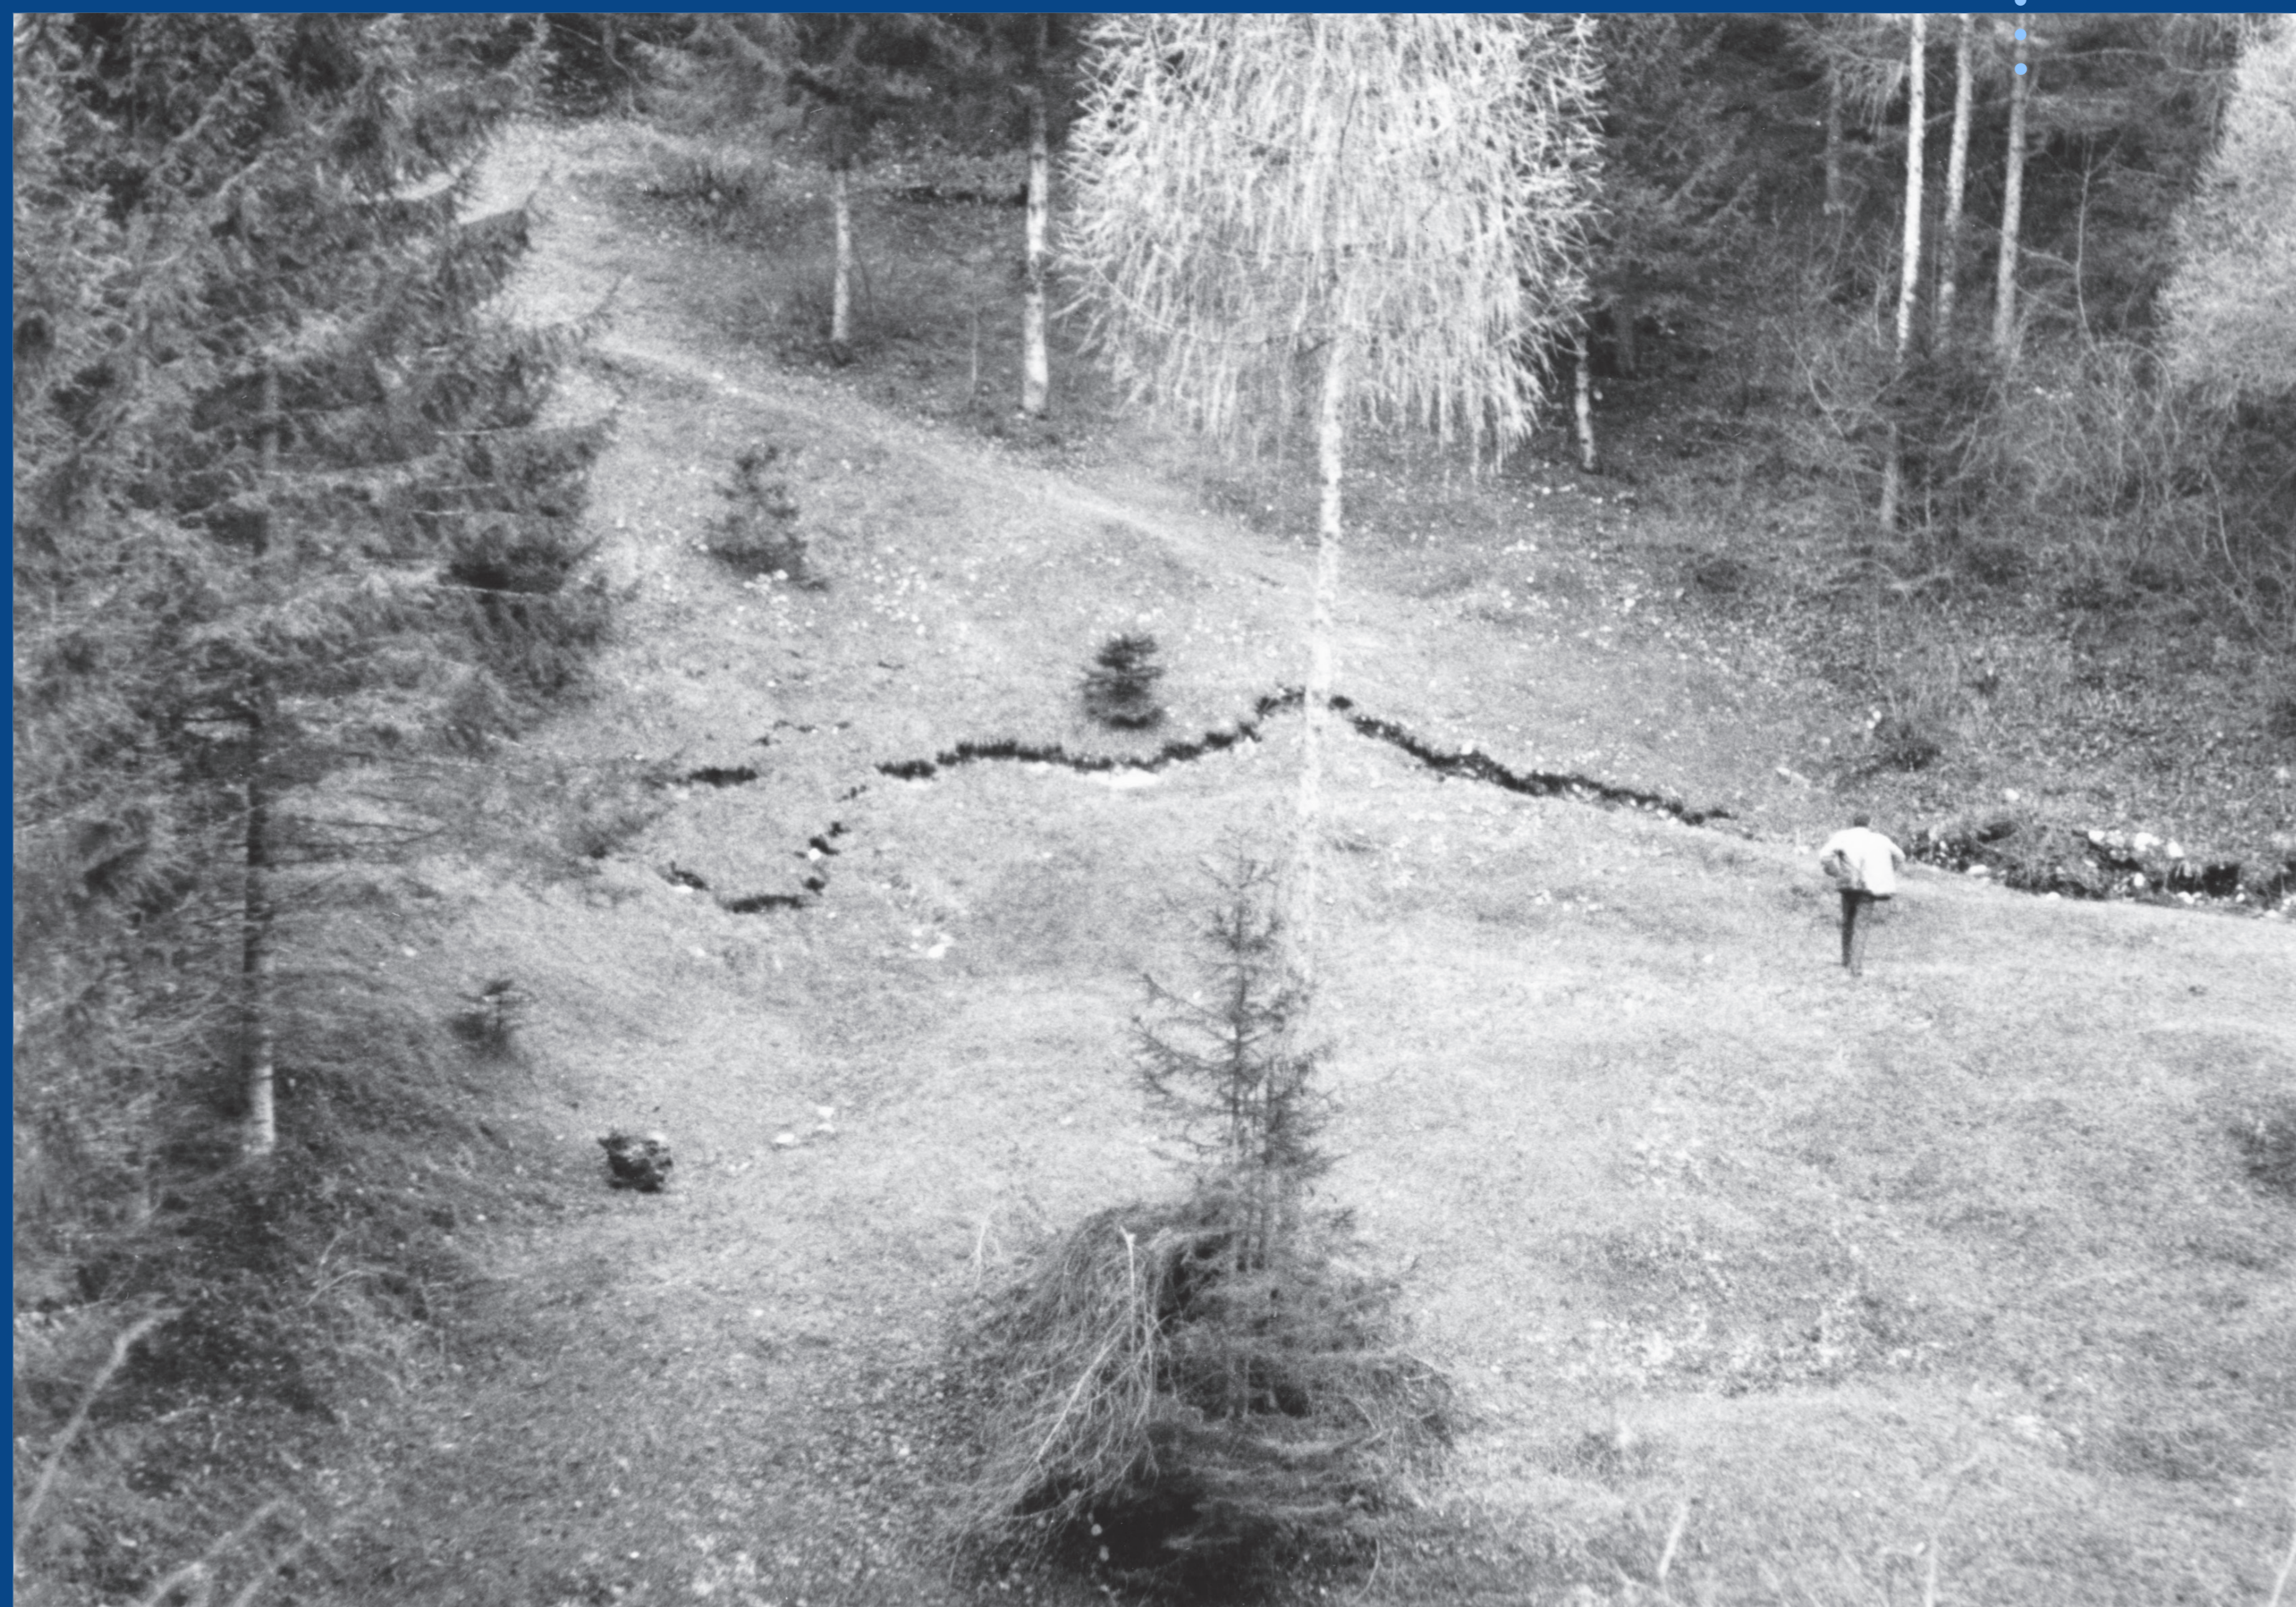
#### 24 - Western part of the perimeter crack: movement parallel to the fracture

This photo shows a portion of the perimeter crack along the west margin of the paleolandslide. The view is downslope; the part of the slope that has moved is on the right. Note that the trees in this area have been tilted in a variety of directions by the movement.

Cracking of the grassy surface is the result of downslope movement of the rock mass.

The crack, which was 50 to 100 cm wide, delineated the margin of a large rock mass moving downslope, to the north, at an angle of 30-40°. To the west, the crack turned downslope, delineating the western margin of the moving rock mass (photograph 24).
